PERFORMANCE TEST REPORT

Cyclic Shear Load Evaluation of FastCap Fasteners

Report No: A3106.01-106-31
Report Date: 09/15/10
Expiration Date: 09/06/14
Revision 1: 02/04/11

Project Summary: Architectural Testing, Inc. was contracted by Exxel Pacific GC to perform a cyclic shear load evaluation on four designs of FastCap screws. Testing was performed according to a client-derived test criteria. The average results of testing are contained in the following table:

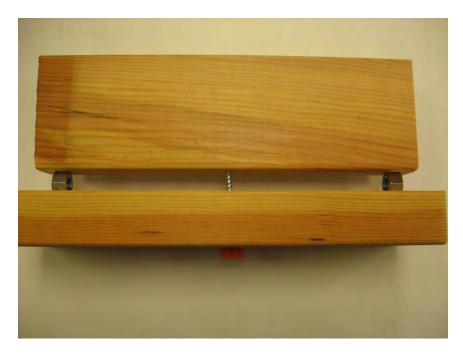
Photo No. 1 Deflector SP Fastener 3/4" Spacing - Pull-Out Setup

Test Description: An INSTRON Model 3367 Universal Testing Machine (ICN 005740) was utilized to perform the evaluations. The wall header section of the test assembly was restrained to the base of the test machine, while the joist section of the test assembly was attached to the moveable crosshead of the test machine. Each test assembly was cycled incrementally until the fastener failed or pulled out of the Douglas fir joist. (See photos in Appendix A for more detail).

Deflector SP - Orange w/ Chrome #10 screw at 3/4" Spacing (20 pound incremental loading, 0.25" per minute)

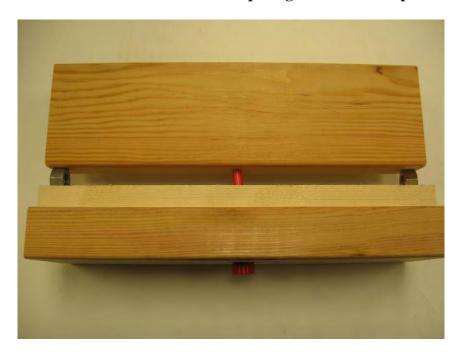
Photo No. 2 Deflector Fastener 3/4" Spacing - Pull-Out Setup

Deflector - Red w/ Aluminum #10 screw at 3/4" Spacing (50 pound incremental loading, 0.50" per minute)

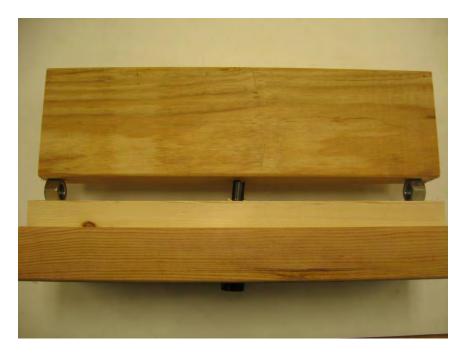
Photo No. 3 Deflector Max Fastener 3/4" Spacing - Pull-Out Setup

Deflector Max - Black w/ Black #14 screw at 3/4" Spacing (50 pound incremental loading, 0.50" per minute)

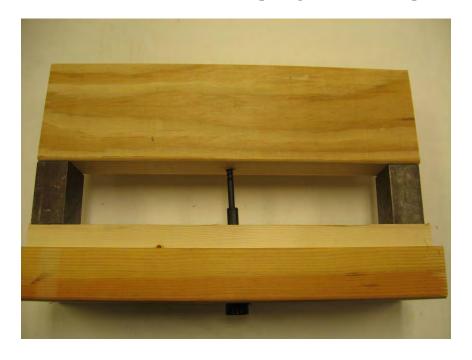
Photo No. 4 Deflector Max Fastener 2" Spacing - Pull-Out Setup

Deflector Max - Black w/ Black #14 screw at 2" Spacing (50 pound incremental loading, 0.50" per minute)

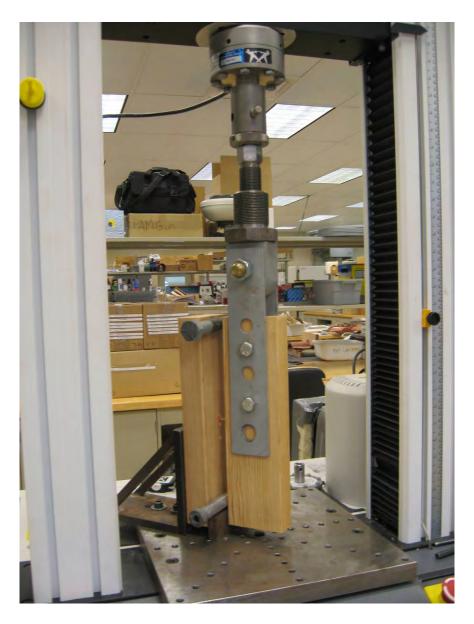
Photo No. 5 Fastener Pull-Out - Setup Detail

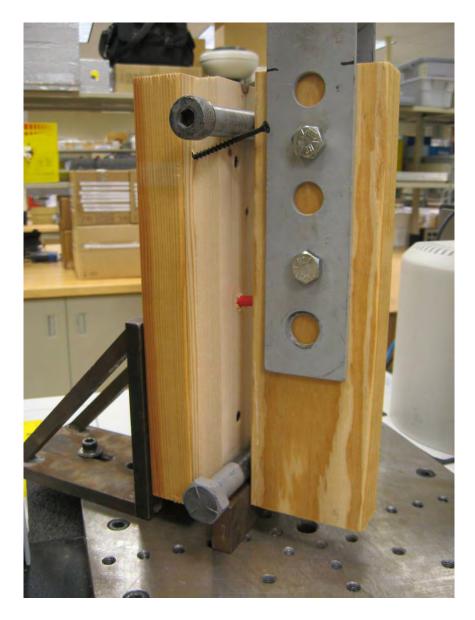
Photo No. 6 Fastener Pull-Out - Setup Detail

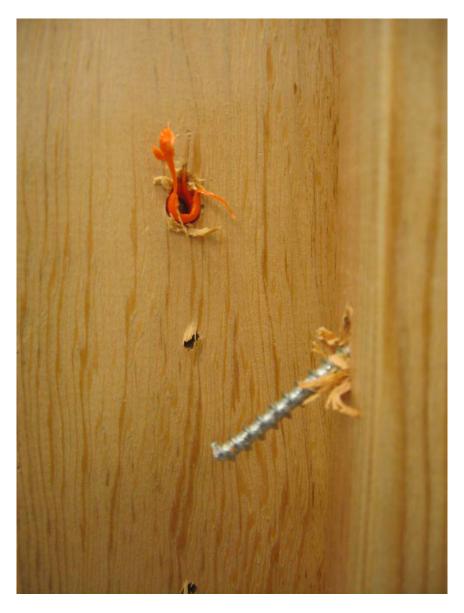
Photo No. 7 Deflector SP Fastener Pull-Out - Failure Detail

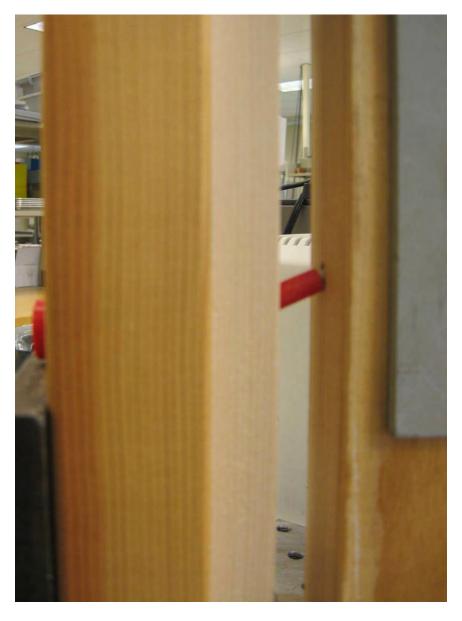
Photo No. 8 Deflector Fastener Pull-Out - Failure Detail

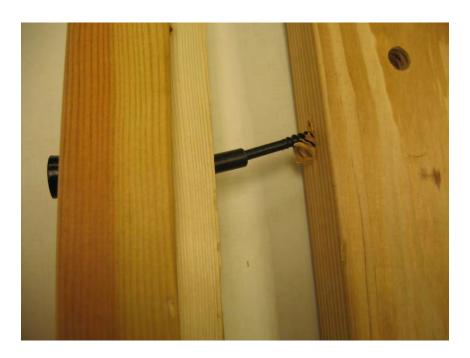
Photo No. 9 Deflector Max Fastener Pull-Out - Failure Detail
